BODY & TRIM

Body mounting bolts tightening torque have been change.

CAB AND REAR BODY

Body Mounting

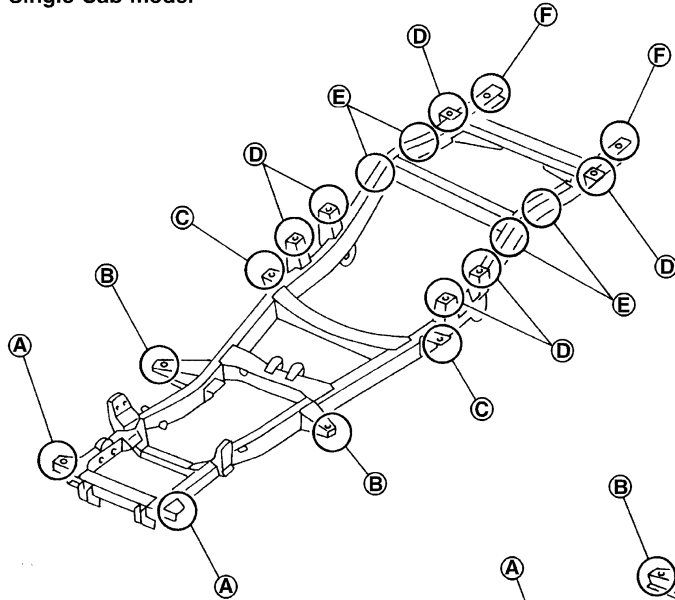
Single Cab model

When removing, be sure to replace bolts and nuts (sealant applied bolts or self-lock nuts are used for all mounting).
